State of California
The Resources Agency
DEPARTMENT OF WATER RESOURCES
Division of Flood Management

**SEPTEMBER
2002
OFFICE REPORT**

**THE INSPECTION OF FLOOD CONTROL STRUCTURES
ON THE SACRAMENTO AND SAN JOAQUIN RIVERS
AND THEIR TRIBUTARIES**

**Prepared By The
Flood Operations Branch
FLOOD PROJECT INSPECTION SECTION**

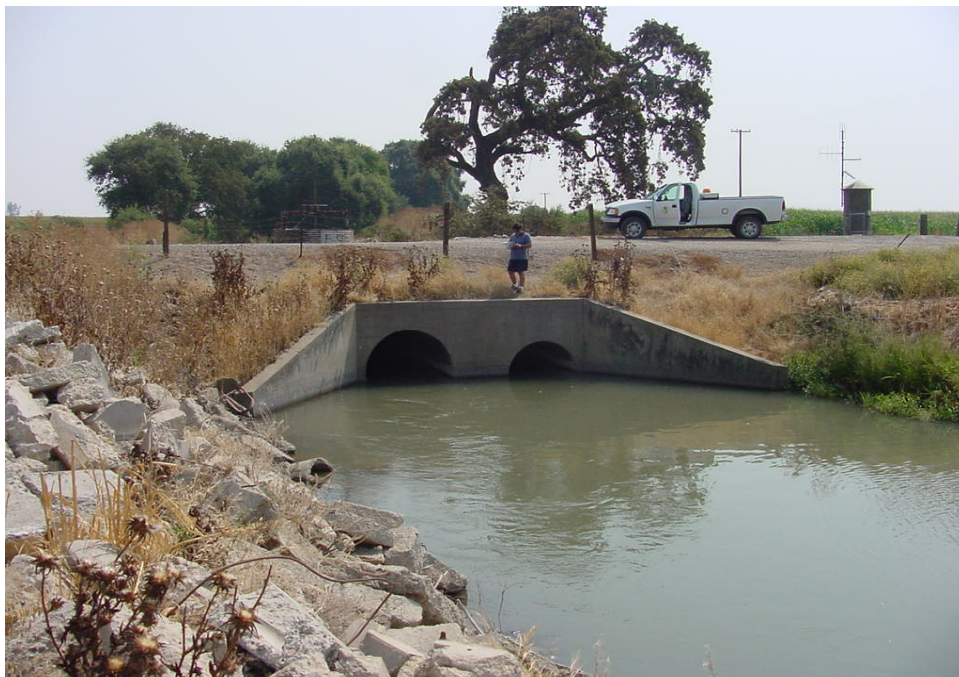
Outlet side of the structure.

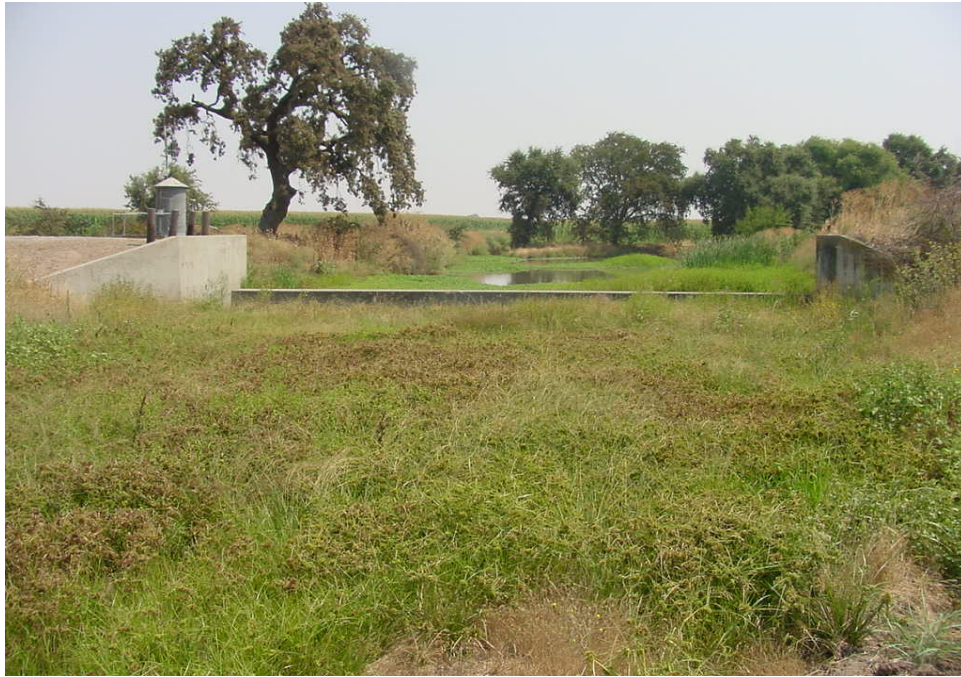
Upstream side of diversion weir.

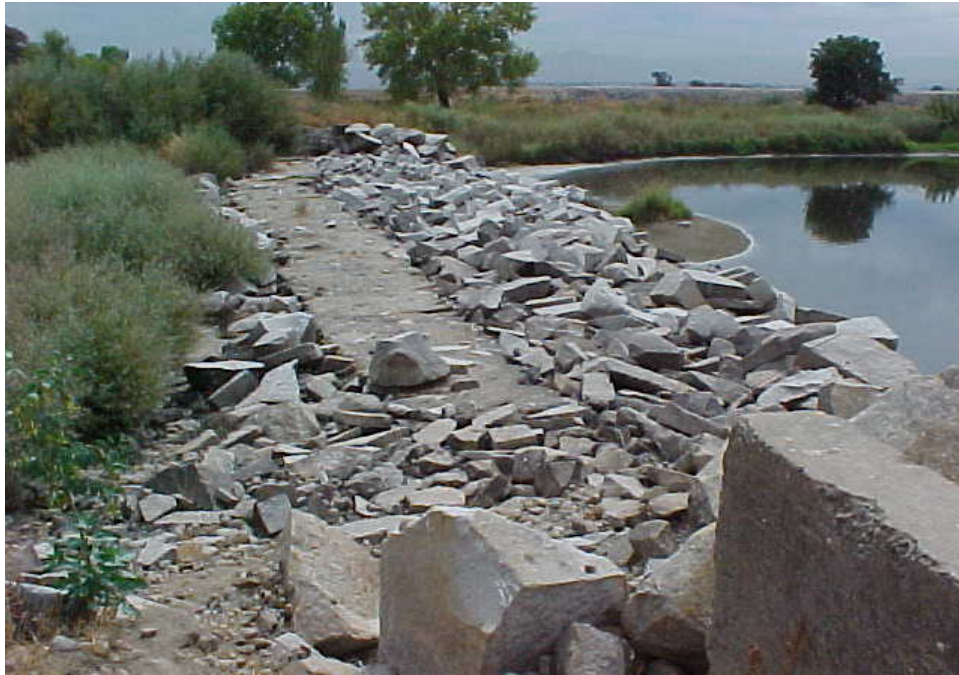
1. Condition of the concrete rubble dam section.
 - a. Good.
2. Accumulation of trash and debris around the structure or in the channel.
 - a. None.
3. Vegetation around the structure and in the channel.
 - a. There are small willow trees on the upstream side of the structure.
4. Comments:
 - a. Willow trees should be removed.

Upstream side of dam.

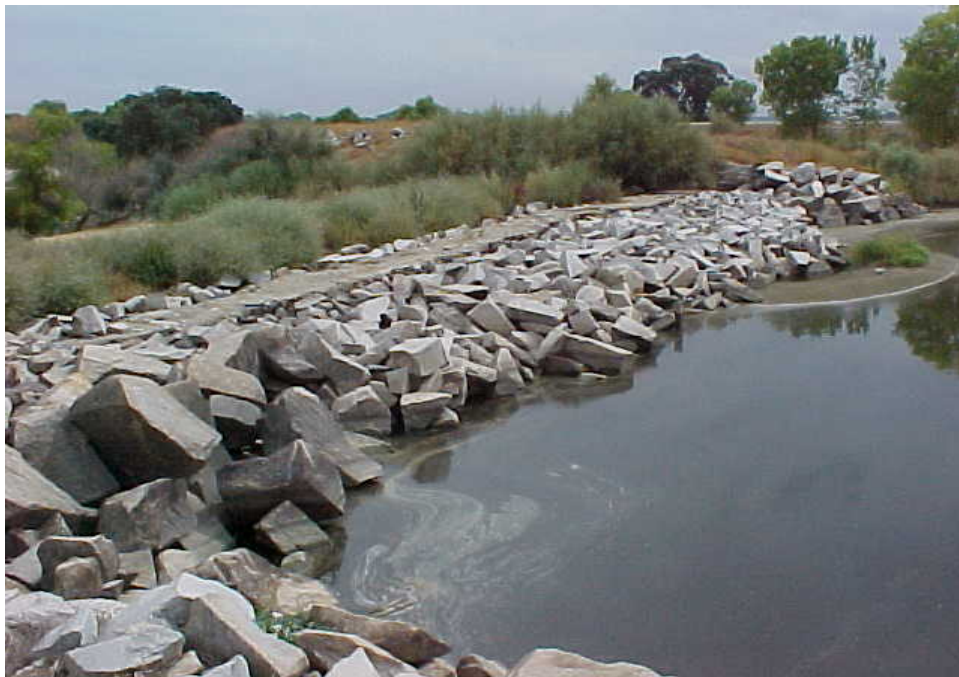
Downstream side of dam.

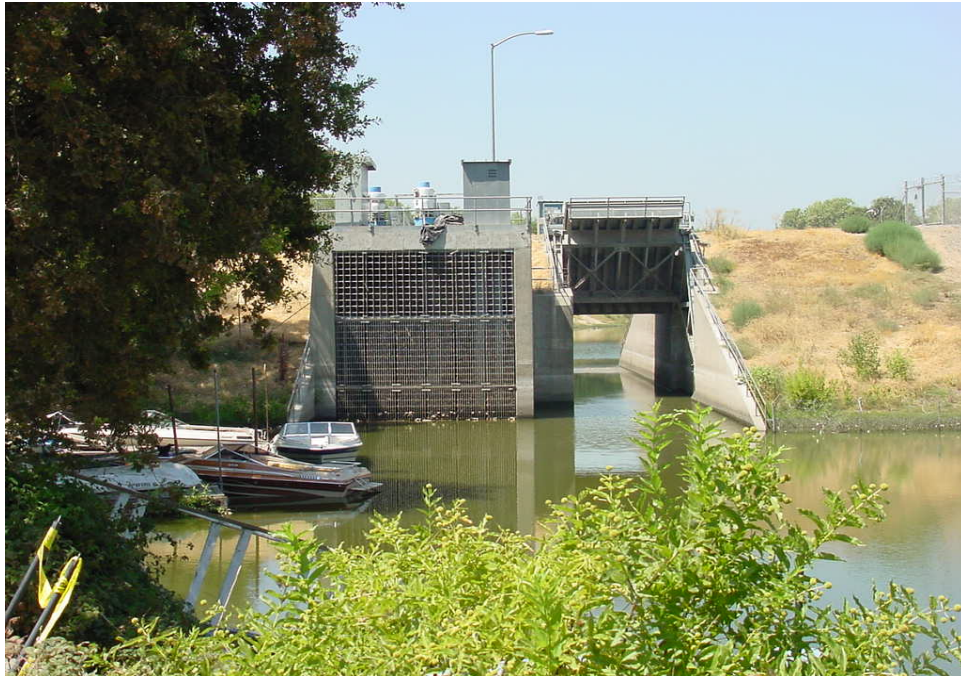
Downstream side of the structure.

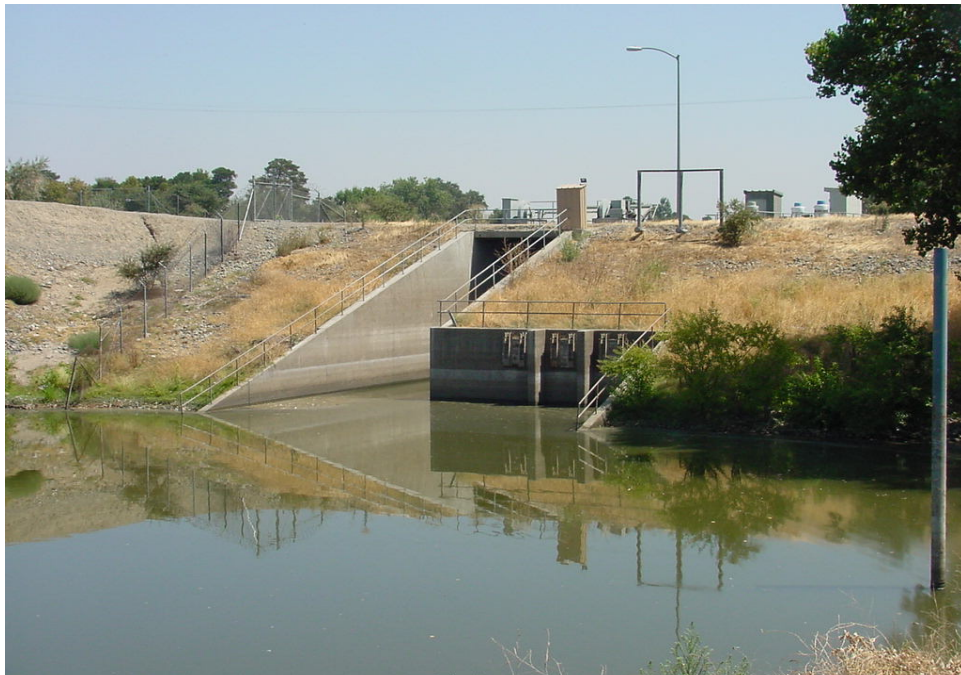
Upstream side of the structure.

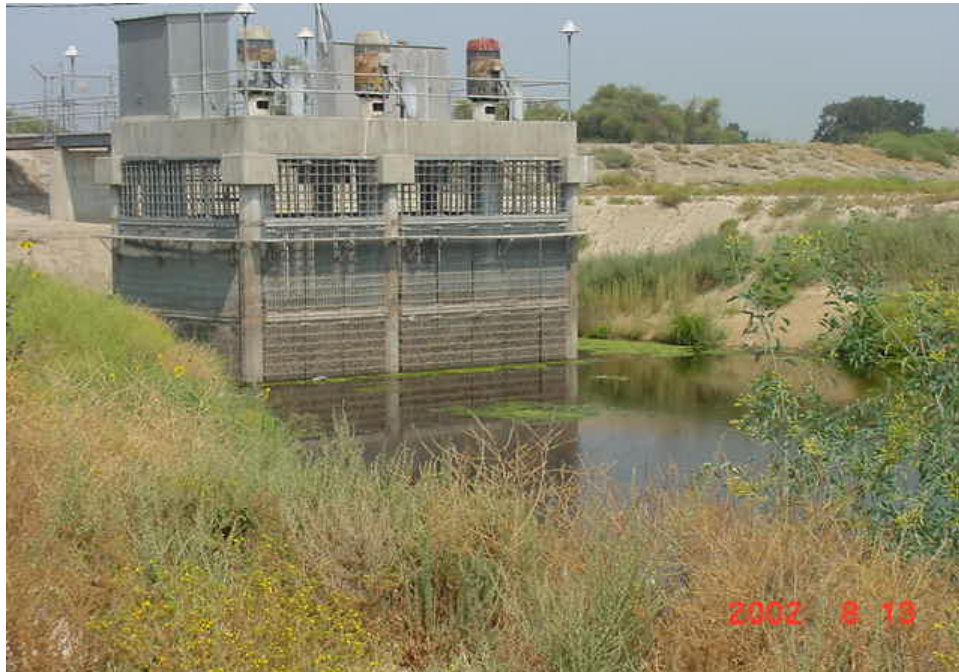
Intake of the pumping plant.

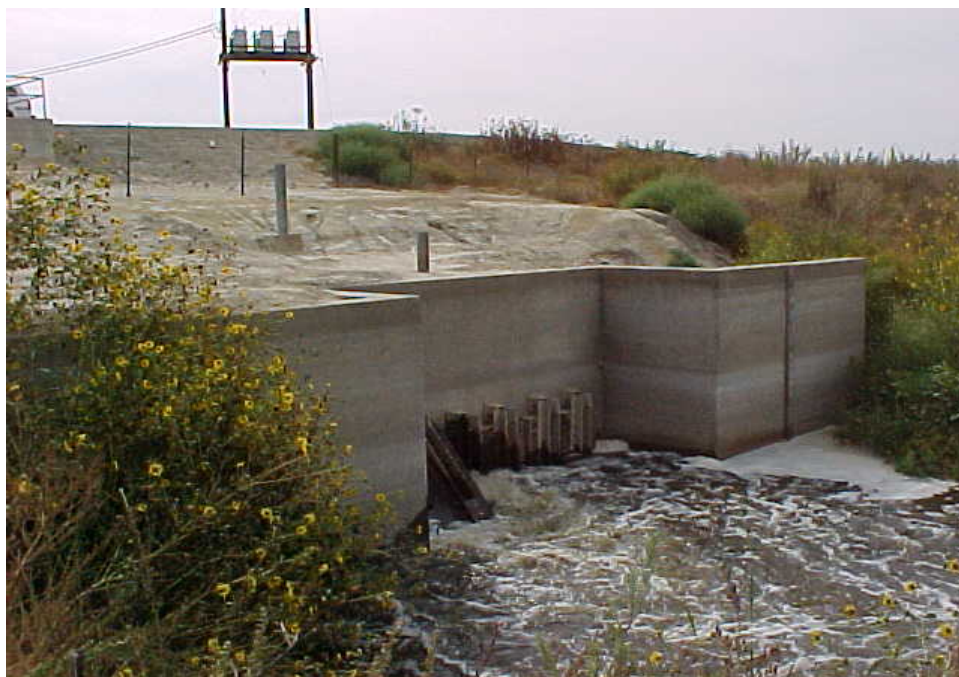
Discharge side of the structure from the north side.

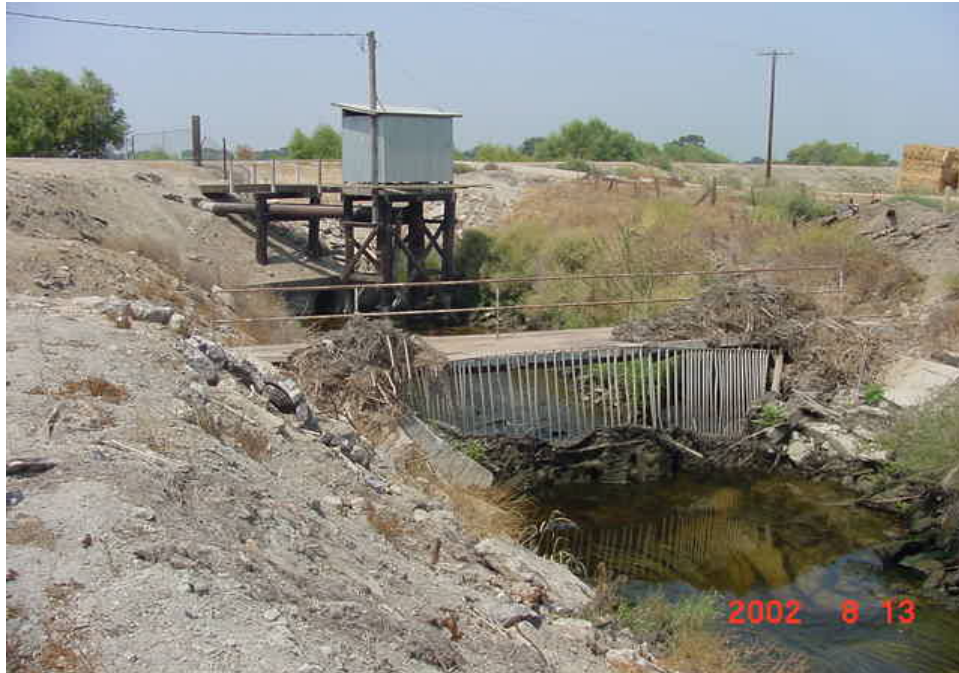
Trash racks and the structure.

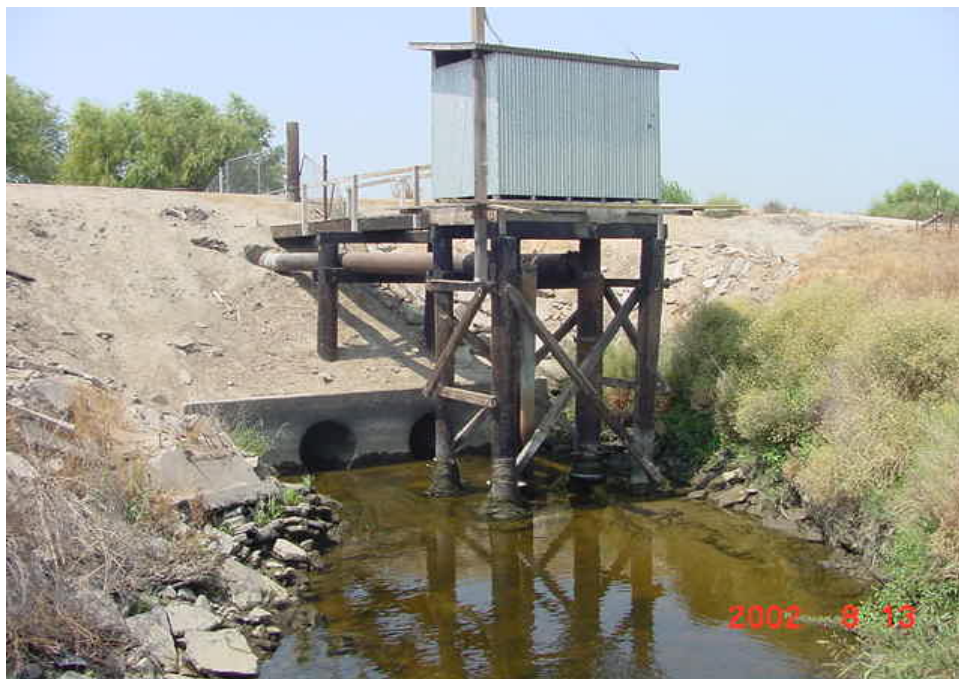
Intake side of the structure.

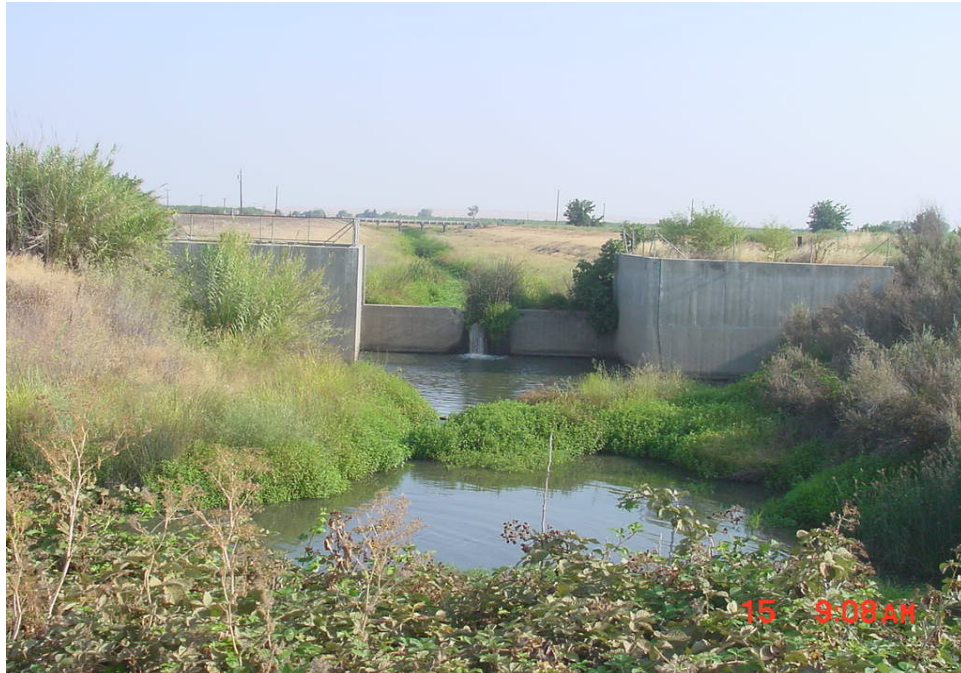
Downstream view of structure.

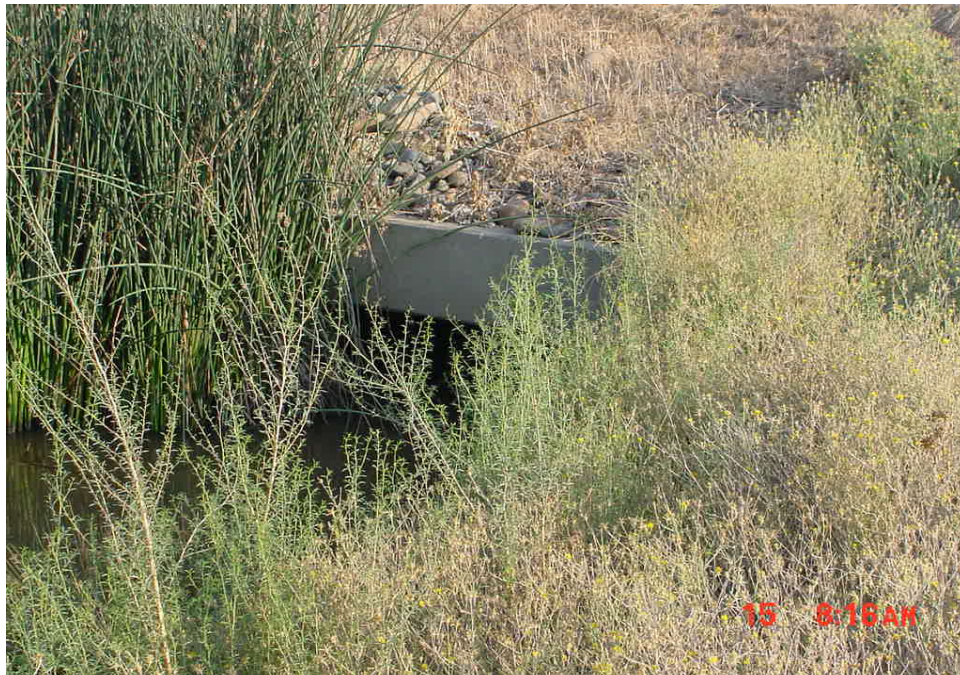
1. Condition of concrete siphon structure.
 - a. Good.
2. Condition of concrete abutments and wing walls.
 - a. Good.
 - b. Separation of the left bank wall is stable.
3. Condition of revetment.
 - a. Good.
4. Accumulation of trash and debris around the structure or in the channel.
 - a. None.
5. Vegetation around the structure or in the channel.
 - a. There is dense tule and weed growth in the channel immediately upstream and downstream of the structure.
6. Comments:
 - a. Remove weeds and tule growth.
 - b. Fair maintenance.

Downstream side of the structure.

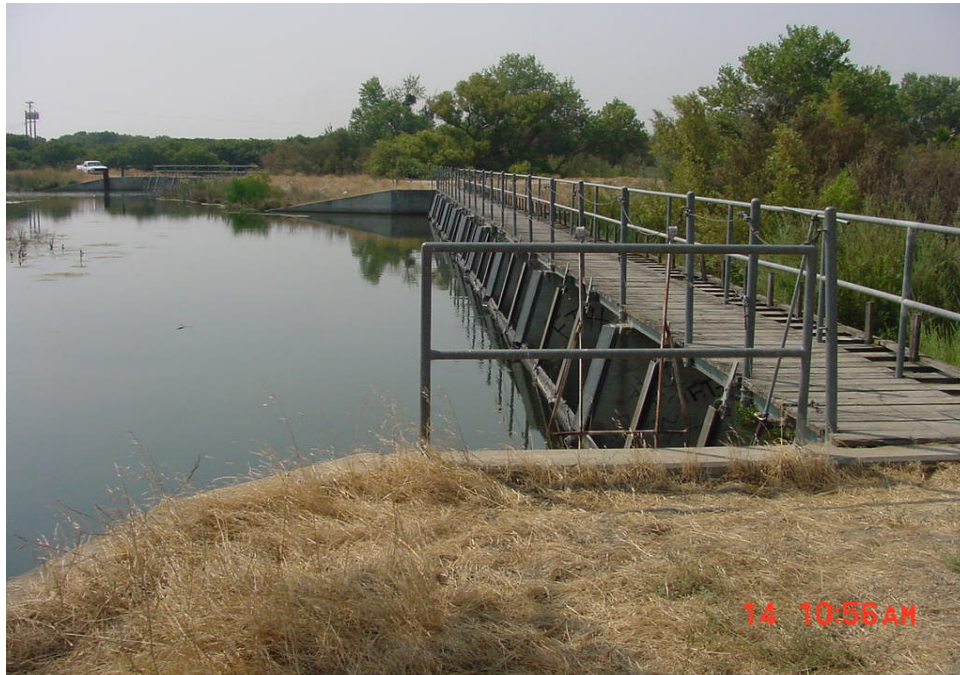
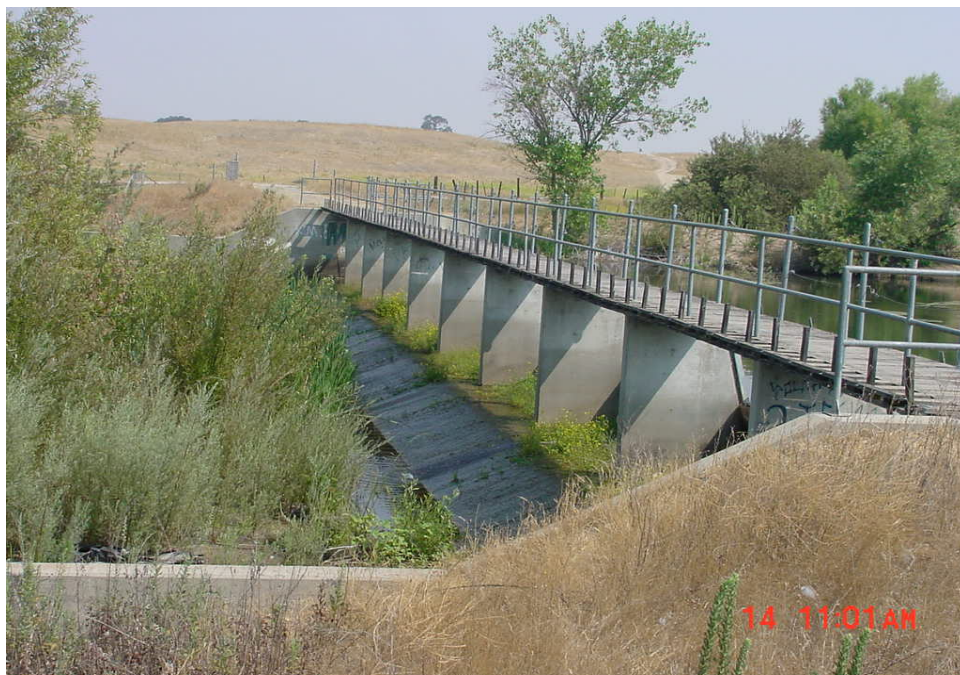
1. Condition of concrete control structures.
 - a. Good.
2. Condition of concrete abutments and wing walls.
 - a. Good.
3. Condition of stop logs and supports.
 - a. Good.
4. Condition of revetments.
 - a. Good.
5. Accumulation of trash and debris around the structures or in the channels.
 - a. None.
6. Vegetation around the control structures or in the channels.
 - a. Trees in the channel downstream of the Ash Slough Structure .
7. Comments:
 - a. Remove the trees from the channels and around the structures.
 - b. Good maintenance.

Upstream side of Ash Slough Structure.

Downstream side of the Ash Slough Structure.

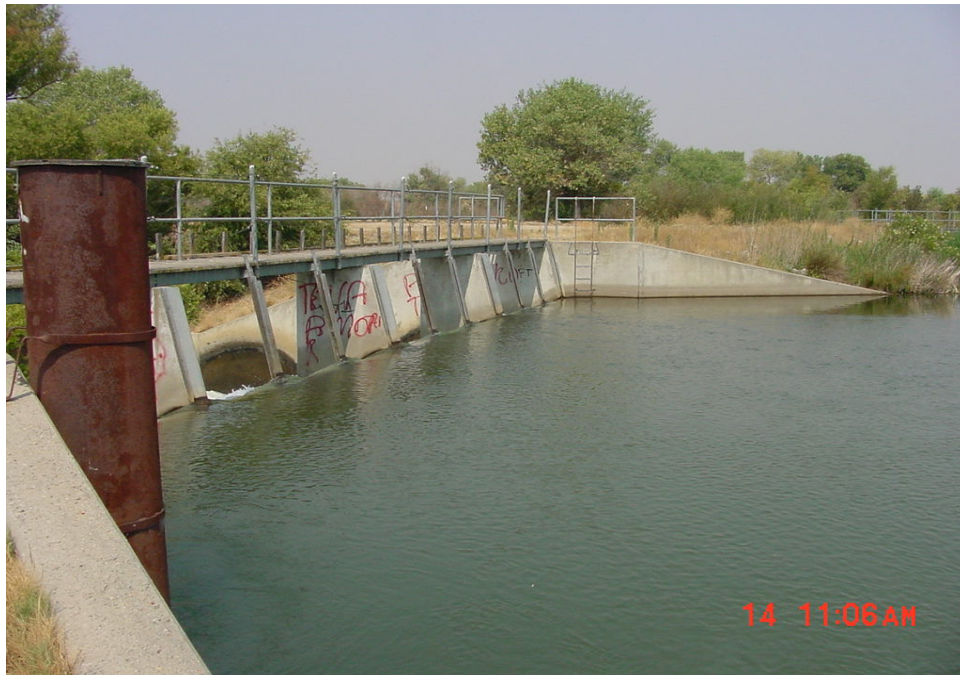
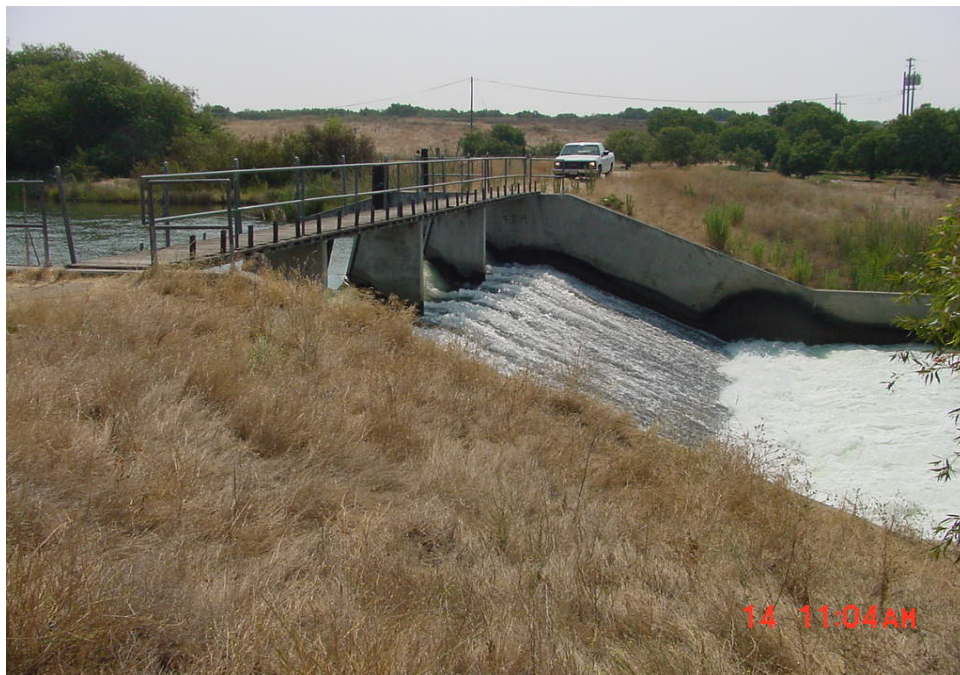
Upstream side of the Berenda Slough Structure.

Downstream side of the Berenda Slough Structure.

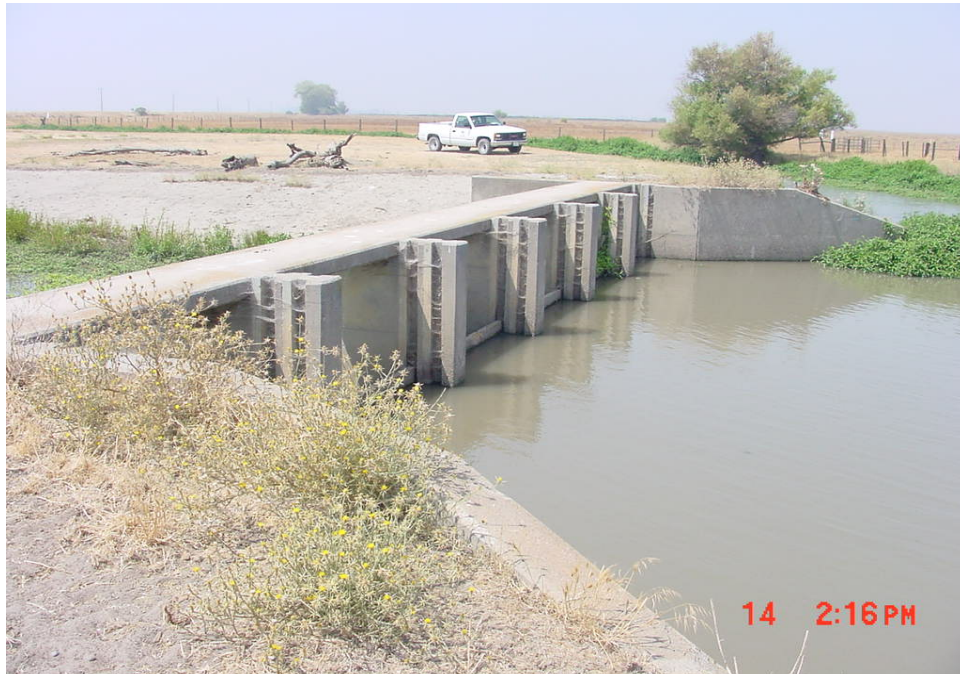
1. Condition of concrete weir structure and stilling basin.
 - a. Good.
2. Condition of concrete abutments and wing walls.
 - a. Good.
3. Condition of revetment.
 - a. Damage to left bank upstream of structure.
4. Accumulation of trash and debris around the structure or in the channel.
 - a. None.
5. Vegetation around the structure or in the channel.
 - a. Yes, on downstream side of structure.
6. Comments:
 - a. Repair left bank before next flood season.
 - b. Good maintenance.

Upstream side of the structure.

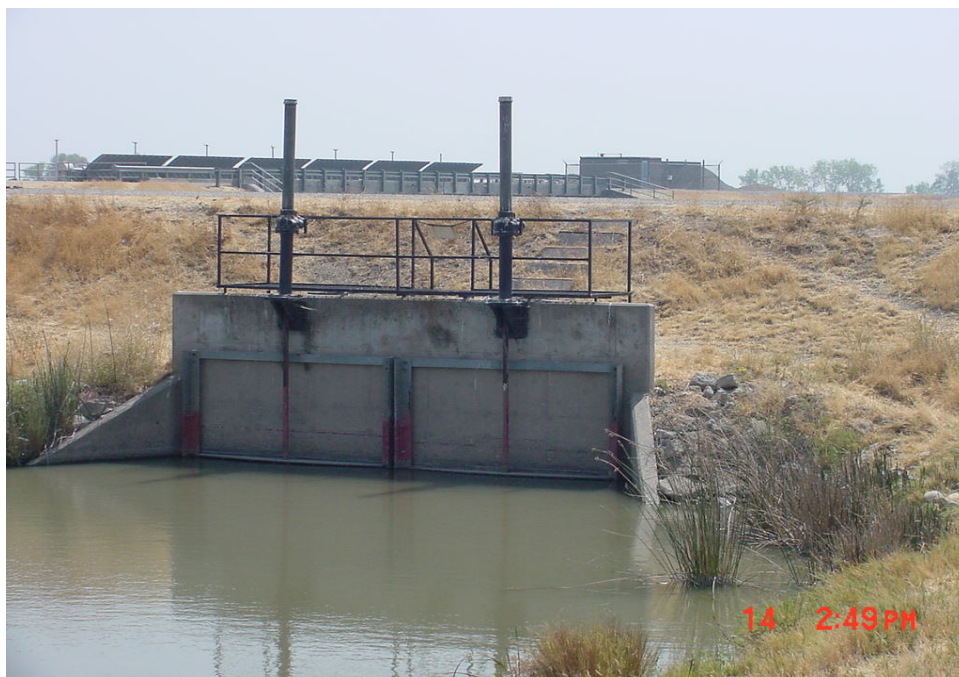
View of the two 72 inch slide gates at the intake side of the structure.

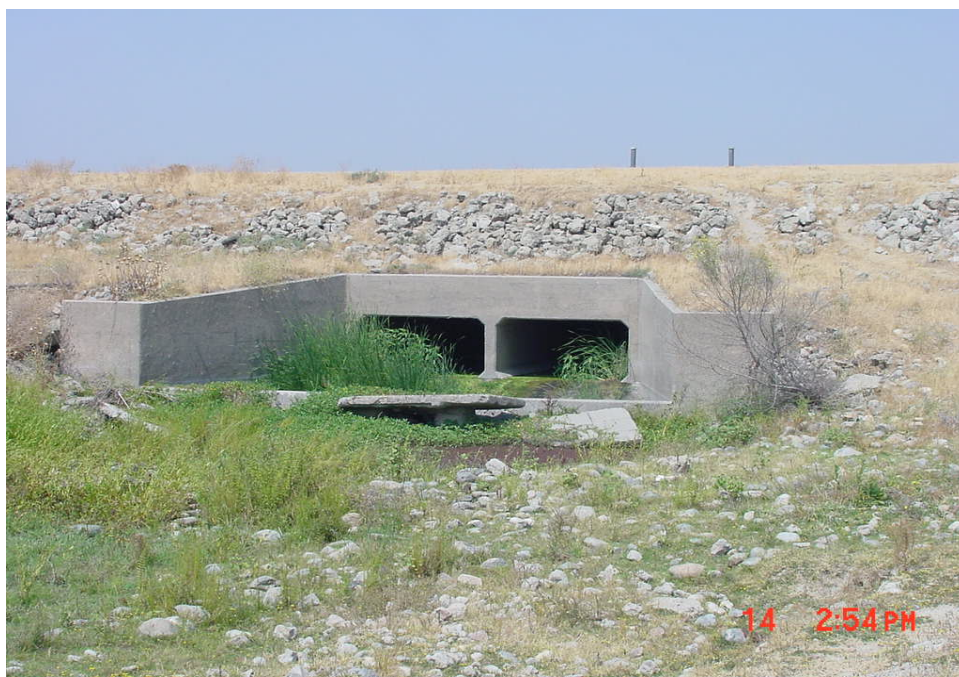
1. Condition of the concrete overflow structure.
 - a. Fair, the concrete apron on the discharge side is damaged.
2. Condition of the abutments and wing walls.
 - a. Good.
3. Condition of the control gates and mechanism.
 - a. Good.
4. Condition of the revetment.
 - a. Good.
5. Accumulation of trash and debris around the structure or in the channel.
 - a. None.
6. Vegetation around the structure or in the channel.
 - a. None.
7. Comments:
 - a. Fair maintenance.
 - b. Repair the concrete apron on the discharge side of the structure.
 - c. Replace moved revetment at downstream edge of structure.

**View of the discharge side of the structure
where it empties into the Eastside Bypass.**

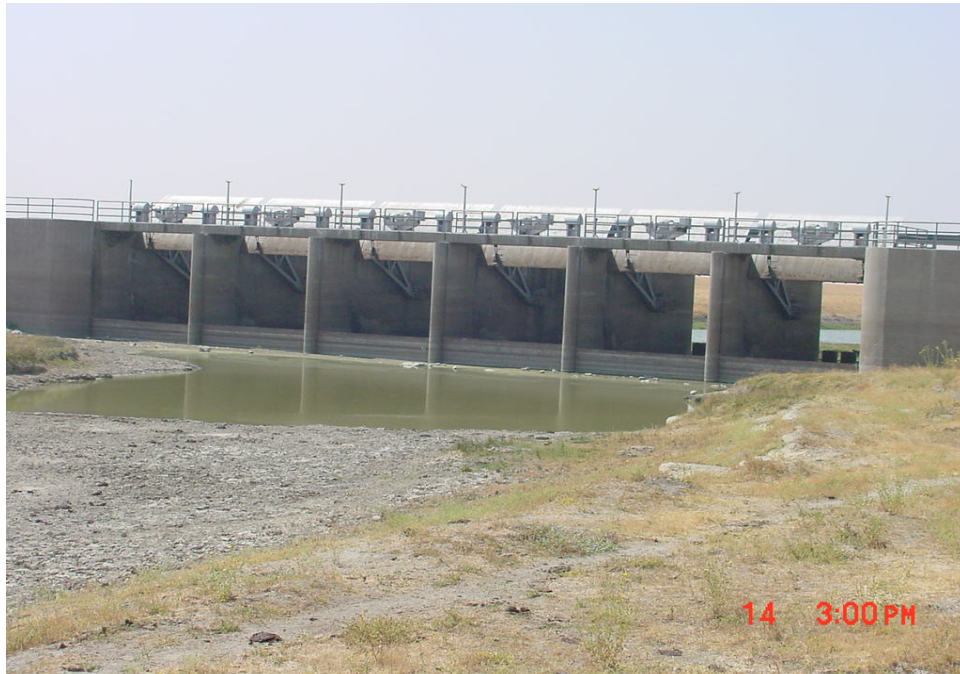
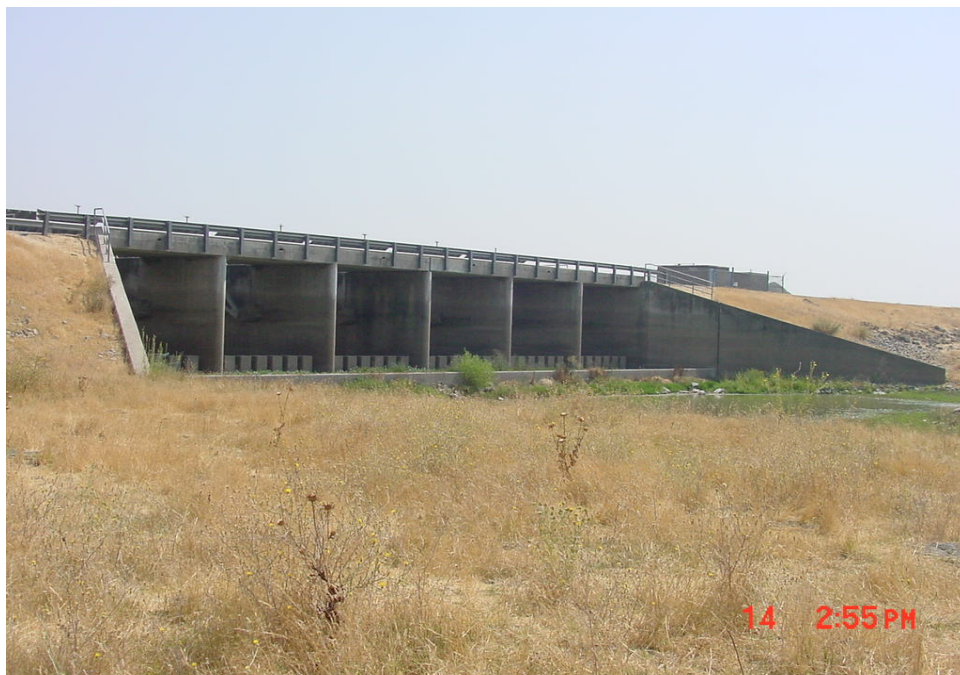
- 10. Vegetation around the structure or in the channel.
 - a. None.
- 11. Comments:
 - a. All the equipment is tested and serviced prior to flood season each year. This structure is well maintained and is in excellent condition.
 - b. Fill in scour hole.
 - d. Good maintenance.
 - e. Six hydraulic brakes are scheduled to be replaced this year.

Upstream side of the structure.

Downstream side of the structure.

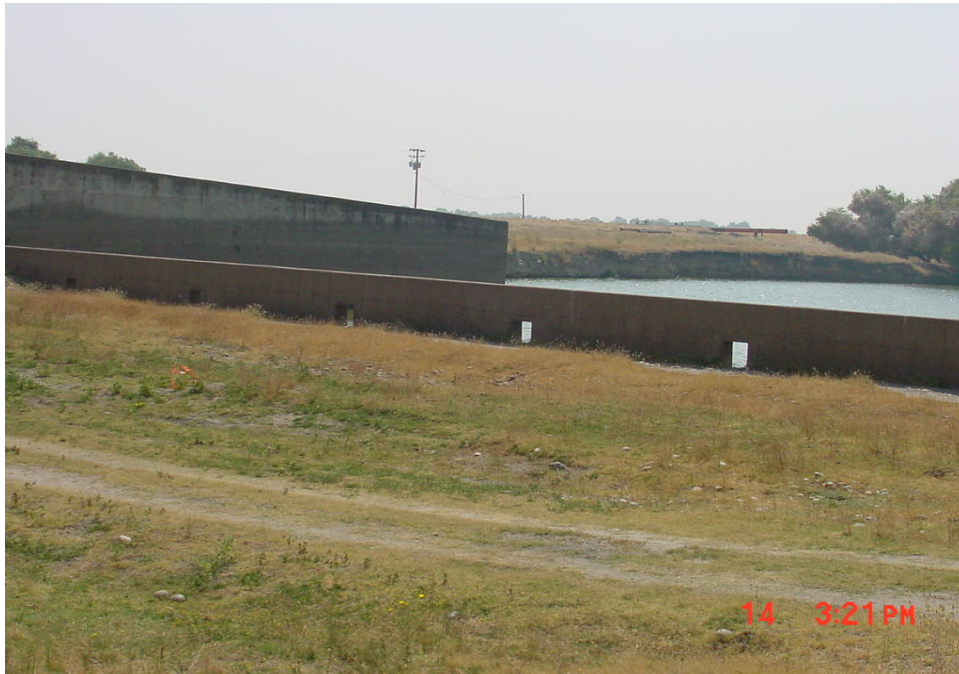
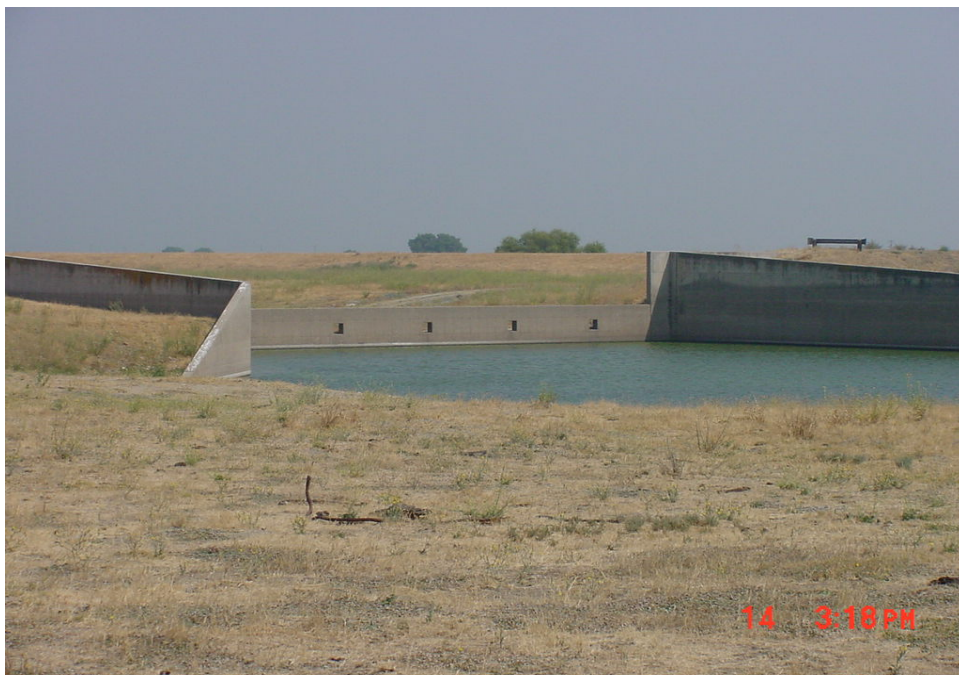
1. Condition of concrete drop structure, stilling basin, and velocity dissipaters.
 - a. Good.
2. Condition of concrete abutments and wing walls.
 - a. Left wing wall has three fourth inch separation at the joint but otherwise it is in excellent condition.
3. Condition of revetment.
 - a. Good.
4. Accumulation of trash and debris around the structure or in the channel.
 - a. None.
5. Vegetation around the structure or in the channel.
 - a. None.
6. Comments:
 - a. Good maintenance.

Upstream side of the structure.

Downstream side of the structure.

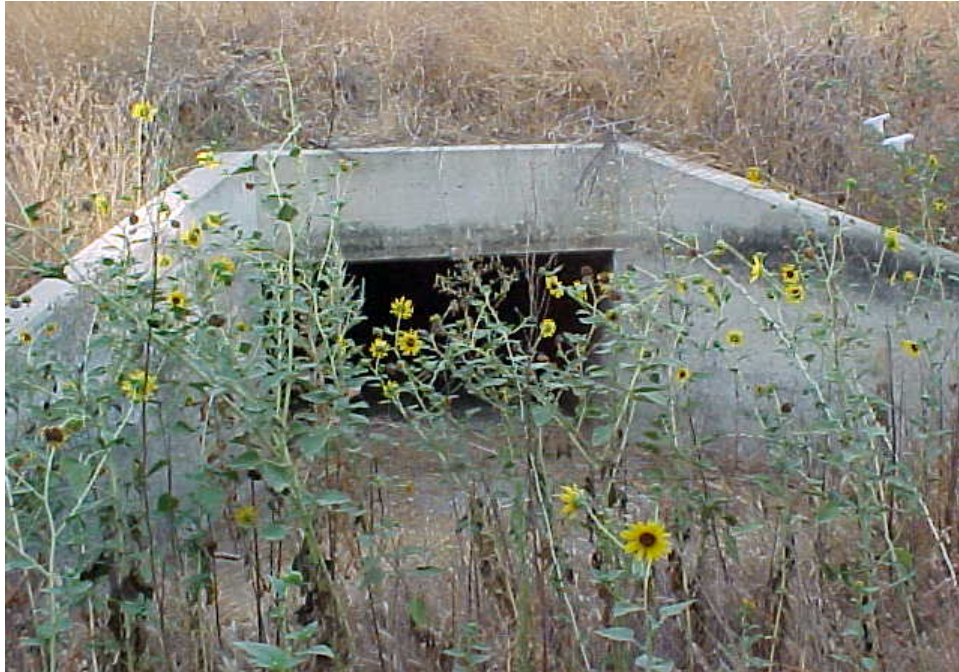
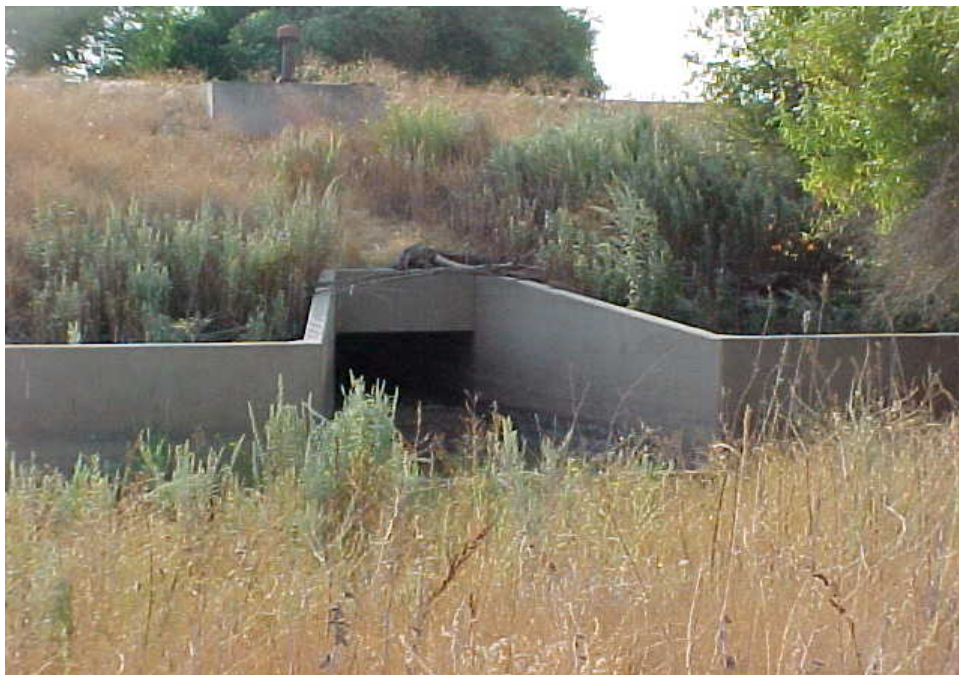
1. Condition of concrete drainage structure.
 - a. Good.
2. Condition of abutments and wing walls.
 - a. Good.
3. Condition of control gate, mechanism, and flap gate.
 - a. The control mechanism is bent.
4. Condition of revetment.
 - a. Good.
5. Accumulation of trash and debris around the structure or in the channel.
 - a. Good.
6. Vegetation around the structure or in the channel.
 - a. None.
7. Comments:
 - a. The control mechanism for the gate needs to be straightened but otherwise, this structure is in good condition.

Intake side of the structure.

Discharge side of the structure.

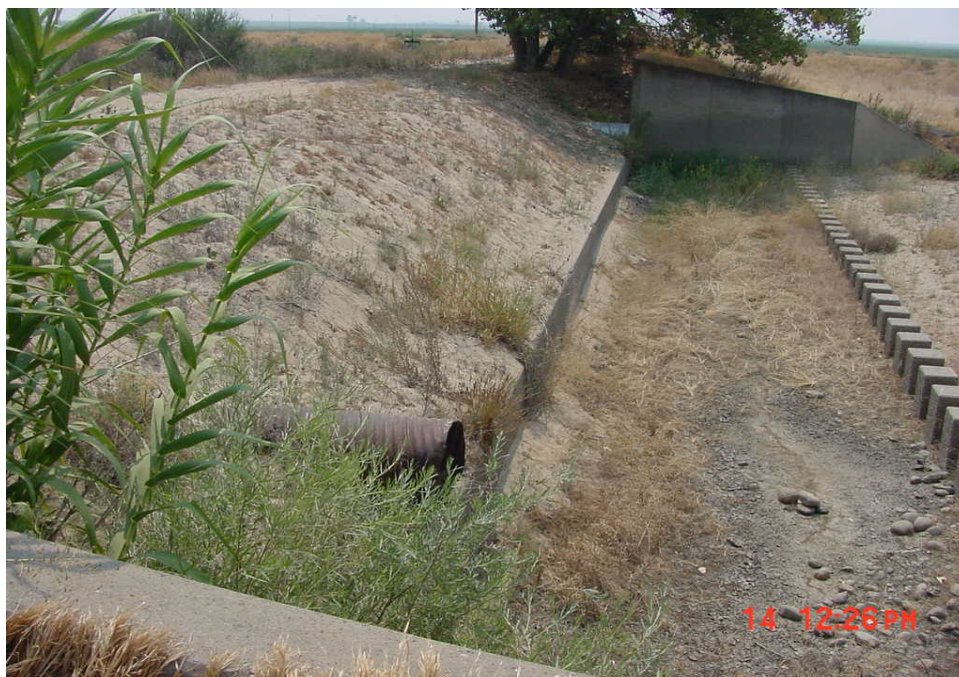
1. Condition of concrete drop structure, stilling basin, and velocity dissipaters.
 - a. What can be seen is in good condition, but a seasonal sand dam is in place backing up water for irrigation purposes on the upstream side.
2. Condition of concrete abutment wing walls.
 - a. Good.
3. Condition of revetment.
 - a. Good.
4. Accumulation of trash and debris around the structure or in the channel.
 - a. None.
5. Vegetation around the structure or in the channel.
 - a. Bamboo growing along right wing wall.
6. Comments:
 - a. The seasonal sand dam on the upstream side is for irrigation purposes and can be easily breached or washed out in the event of high water.
 - b. Remove bamboo.

Downstream side of the drop structure.

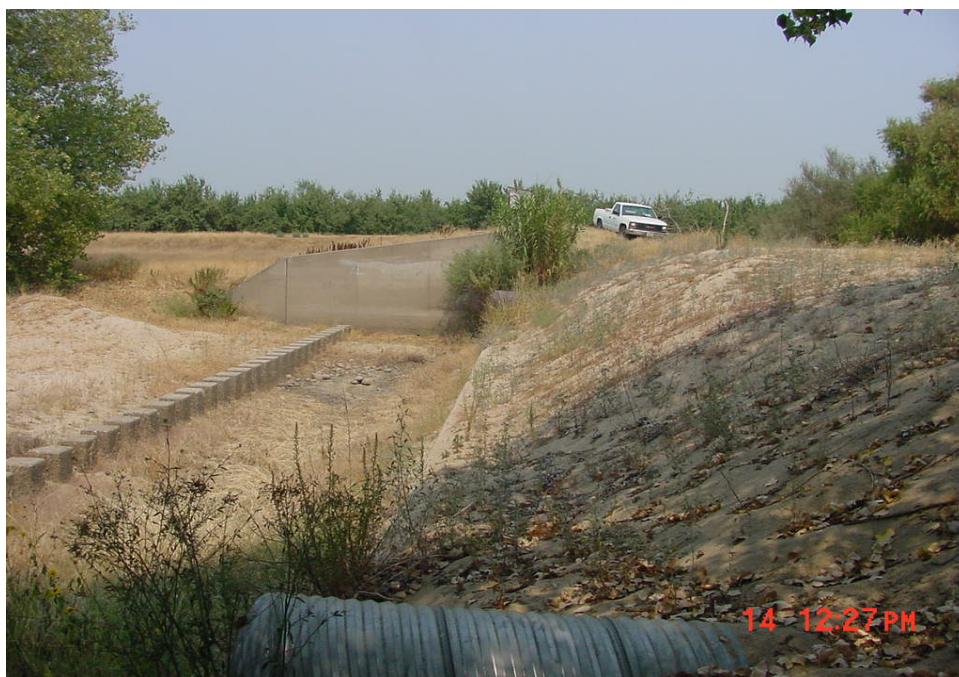
Seasonal sand irrigation dam with two culverts installed.

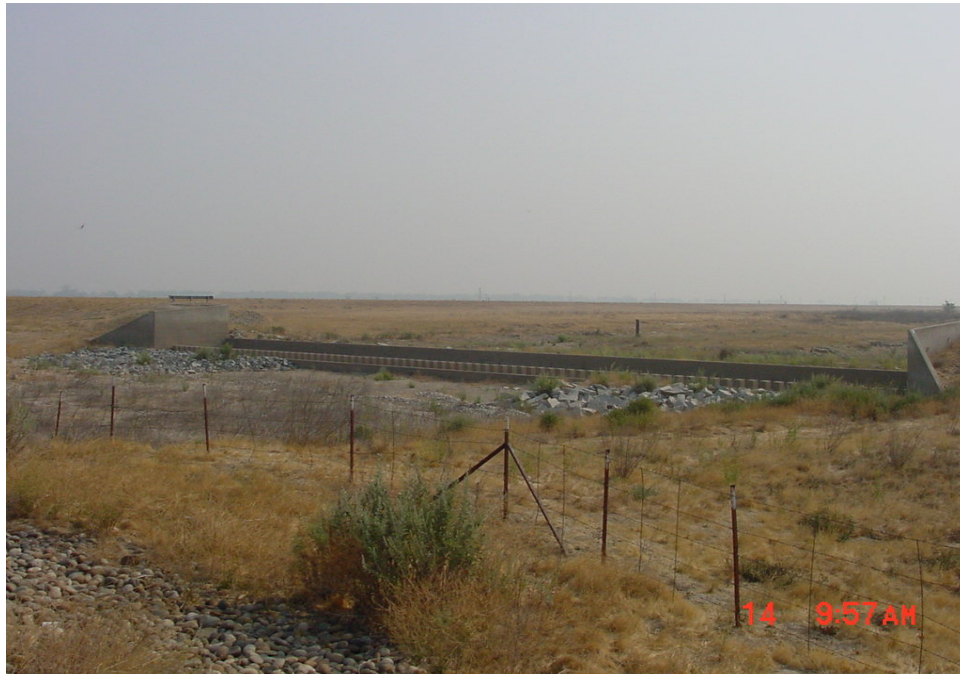
1. Condition of concrete drop structure, stilling basin and velocity dissipaters.
 - a. Good.
2. Condition of concrete abutments and wing walls.
 - a. Good.
3. Condition of revetment.
 - a. Fair one third of revetment gone.
4. Accumulation of trash and debris around the structure or in the channel.
 - a. None.
5. Vegetation around the structure or in the channel.
 - a. None.
6. Comments:
 - a. Good maintenance.

North at the stilling basin and the velocity dissipaters.

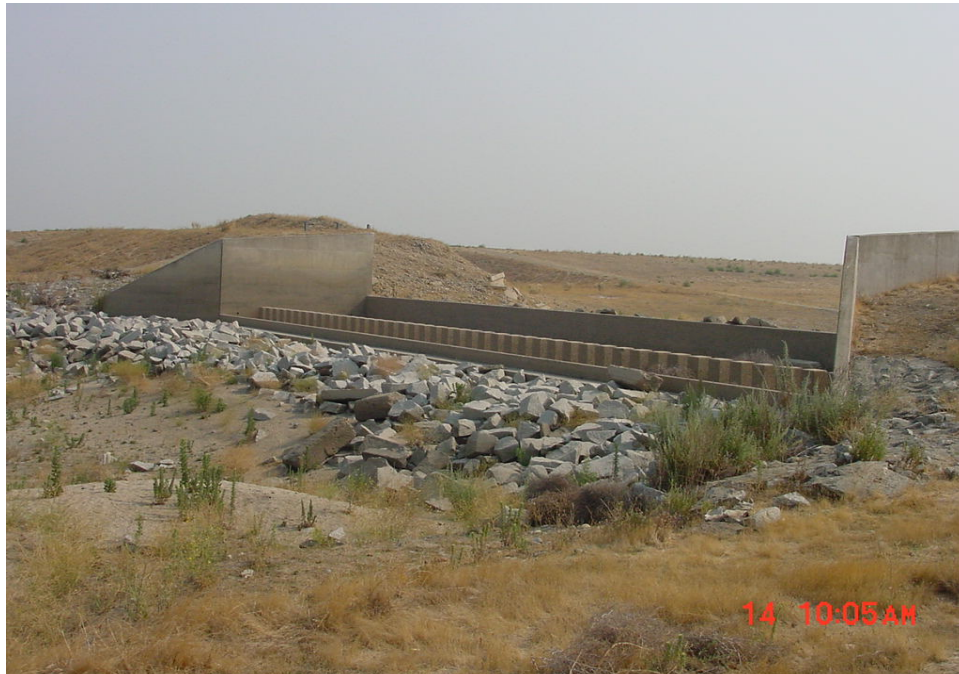
1. Condition of concrete structure, stilling basin, and velocity dissipators.
 - a. Good.
 - b. It was noted last year that concrete spalling exists on the floor of the stilling basin. This was first noted in 1969.
2. Condition of concrete abutments and wingwalls.
 - a. Good.
3. Condition of revetment.
 - a. Good.
4. Accumulation of trash and debris around the structure or in the channel.
 - a. None.
5. Vegetation and debris around the structure or in the channel.
 - a. None.
6. Comments:
 - a. Good maintenance.

Downstream side of the structure.

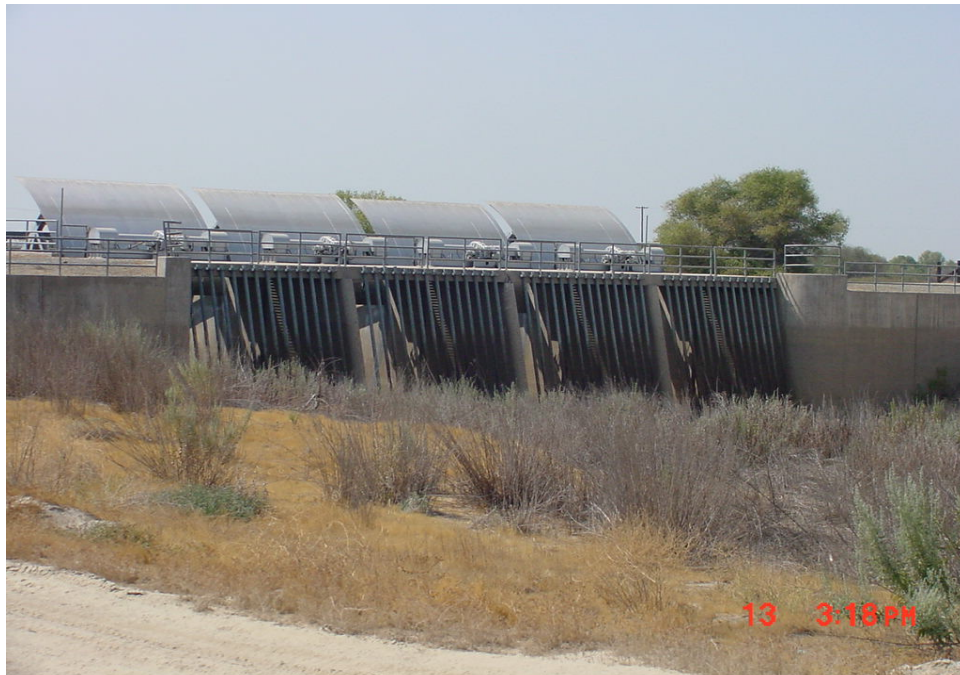
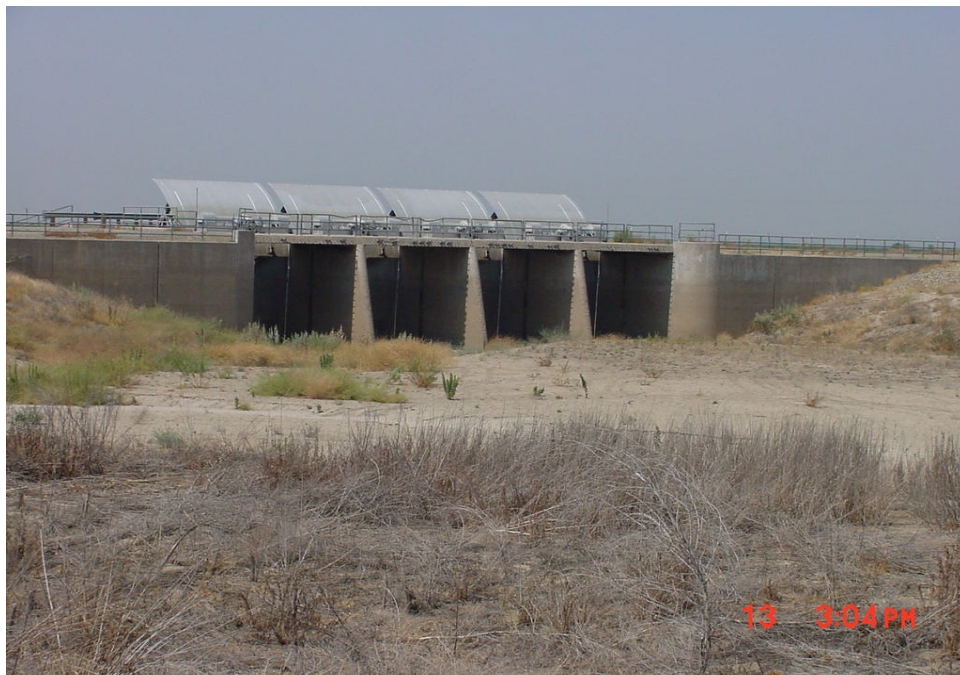
- a. All equipment is tested and serviced by the U.S. Bureau of Reclamation prior to flood season.**
- b. Remove debris against San Joaquin River Control Structure trashrack.**
- h. Good maintenance.**
- i. One hydraulic brake was replace this year**

Downstream side of the San Joaquin River Control Structure.

Upstream side of the San Joaquin River Control Structure.
